Assessing the risk of non-compliant firestopping and smokestopping in New Zealand residential buildings undergoing alterations

Kevin Frank, Greg Baker and Jonathon MacIntyre

BRANZ Study Report SR410

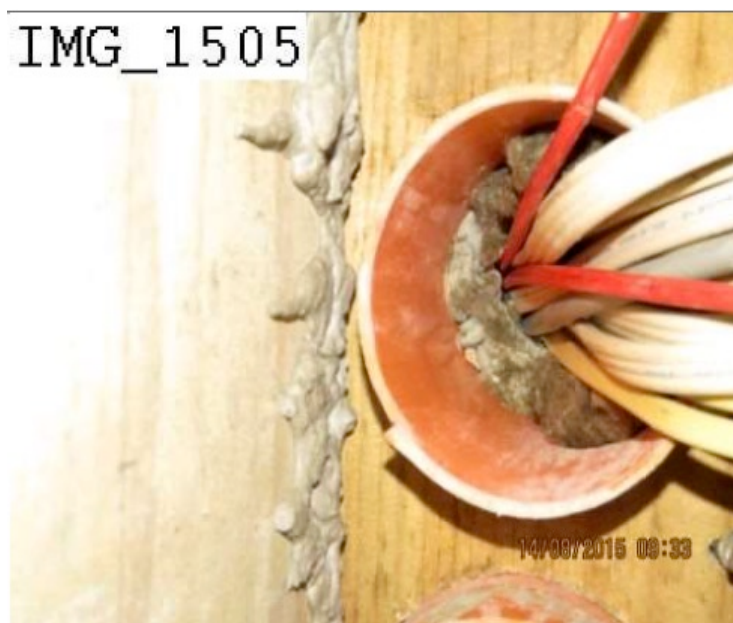
In this case, a cable bundle was installed in a timber/infill floor/ceiling assembly above a car park and below an apartment, as shown in Figure 56. The model inputs are shown in Figure 57.

Figure 56. Cable bundle through timber infill floor.

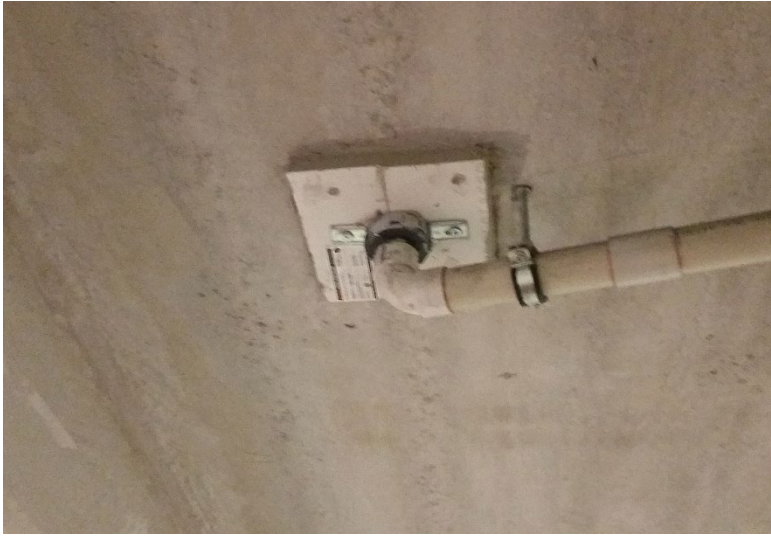
Figure 59. Plasterboard pattress covering a penetration through a concrete ceiling.

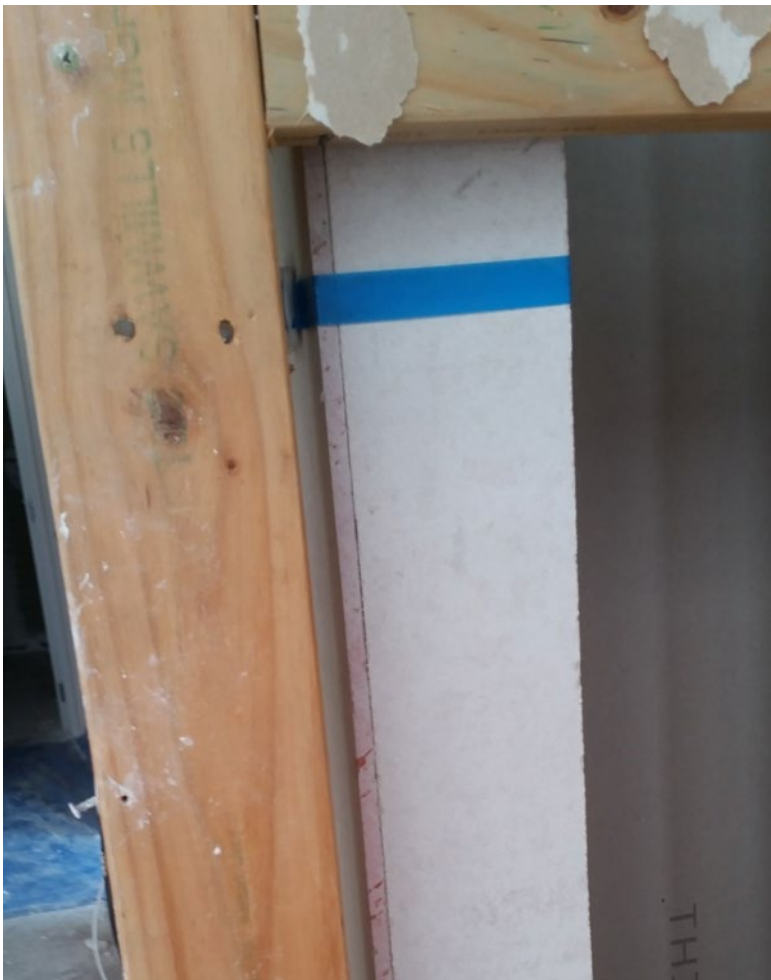
Figure 60. Plasterboard bulkhead held together with combustible plastic strapping.

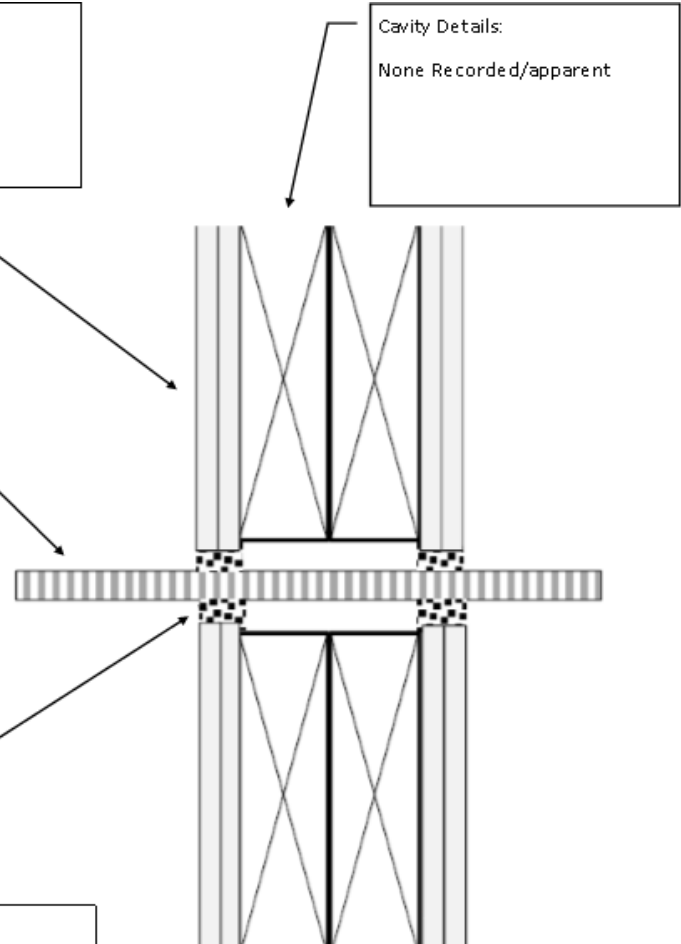
Sketch Number: 09

Cavity Details: None Recorded/apparent
Location: Corridor (Means of Escape)		
Wall Lining Type: Gypsum Plasterboard - Standard (appears)		
Thickness: 2 x 13mm		
Penetration Type: Non-combustible duct		
Penetration Diameter: 150 mm		
Hole Details: 160mm		
PFP System: See Comments		
Sealant Details: None		
Comments: Corridor wall into apartment. Two ducts observed. The first was unsealed and the second has stopping around the penetration (no label to identify if the stopping material is fire rated).
